Department of Bangladesh Haor and Wetlands Development
Ministry of Water Resources

Impact Assessment of Structural Interventions in Haor Ecosystem and Innovations for Solution

Field Report of BWDB Schemes

Volume III

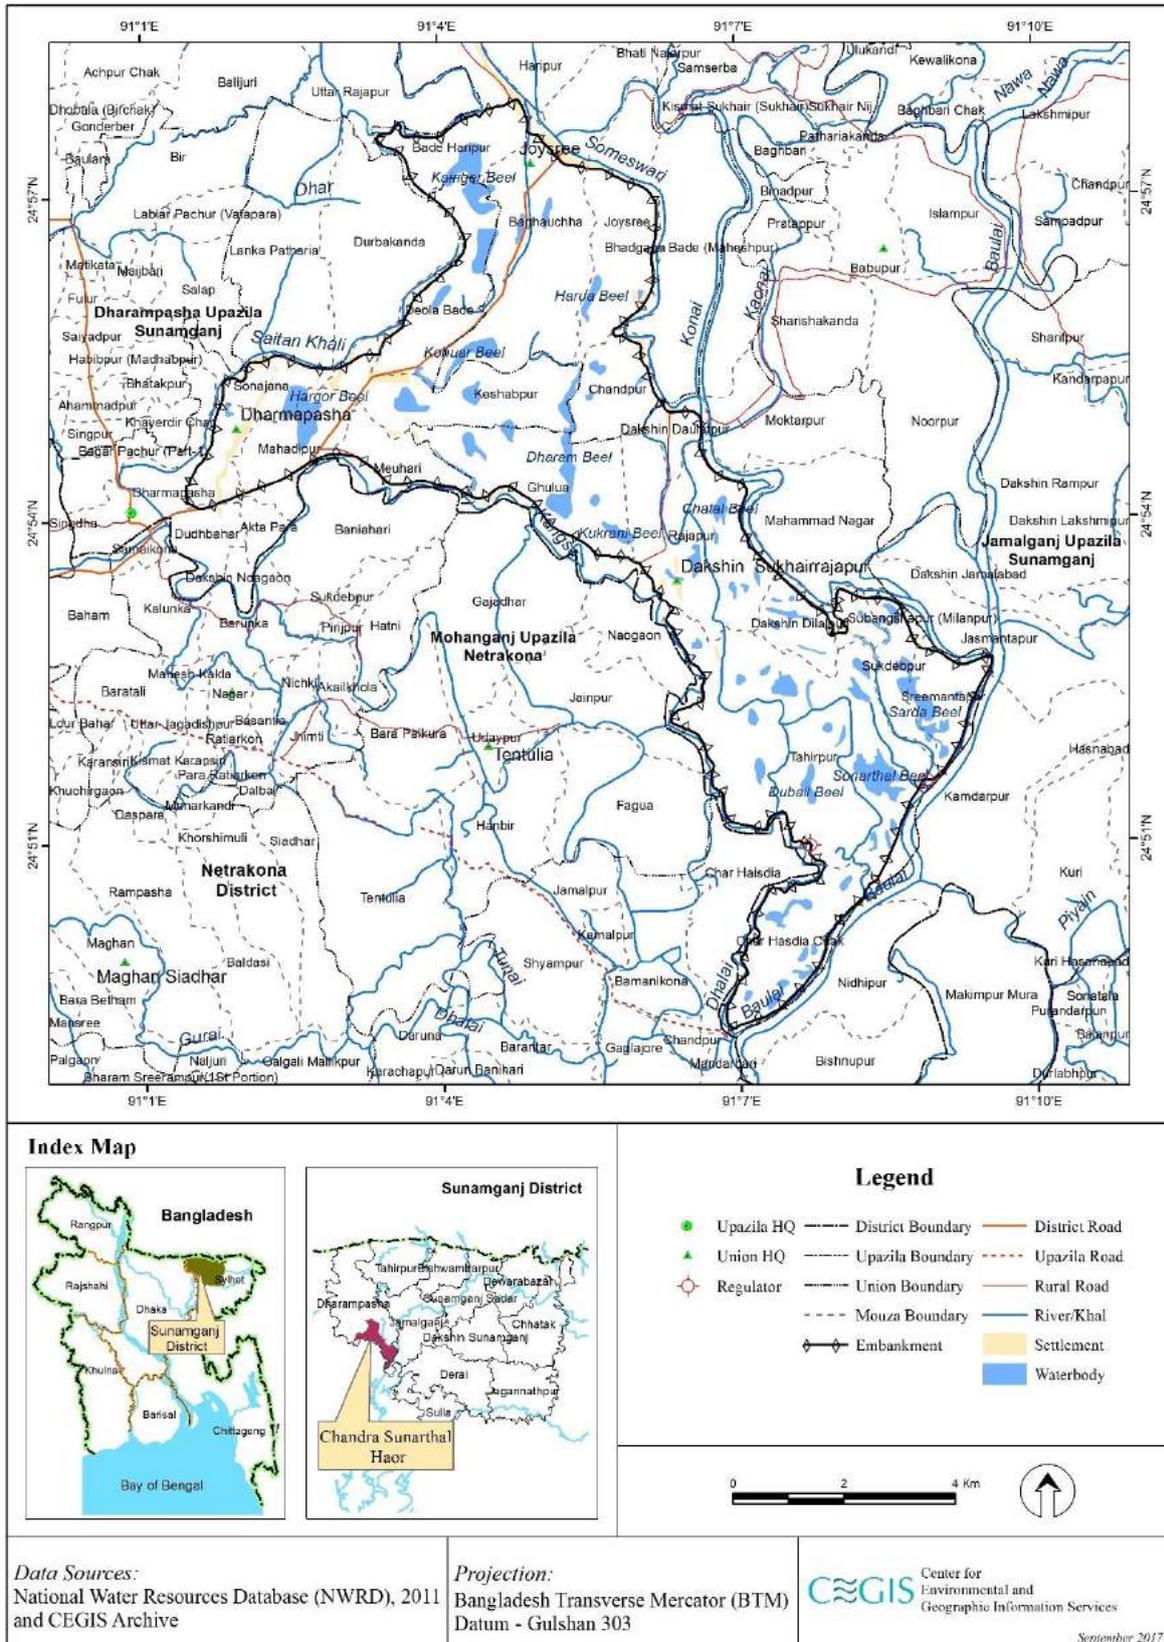
Figure 1.1: Hydrological features of Chandra Sunarthal Haor System

- 64 km embankment,
- 3 numbers of regulators
- 5 numbers of pipe sluices

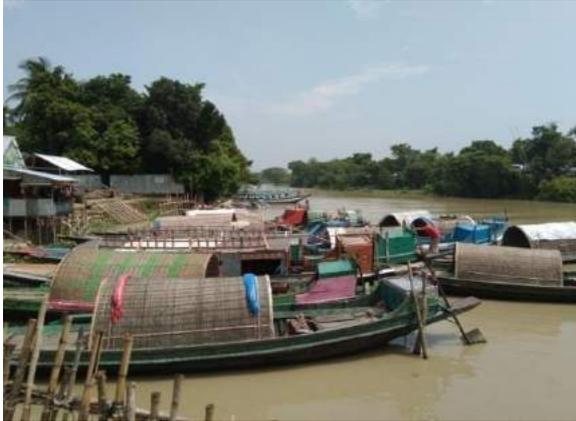
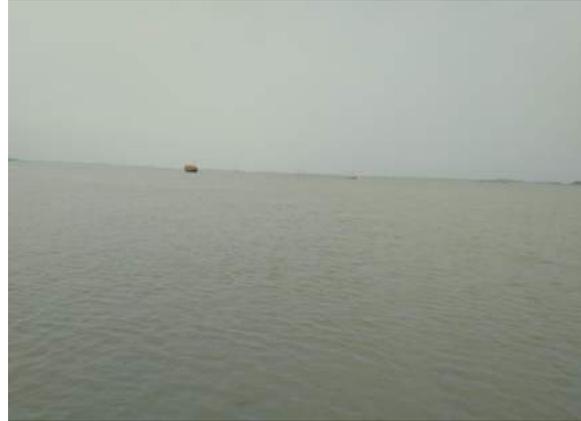
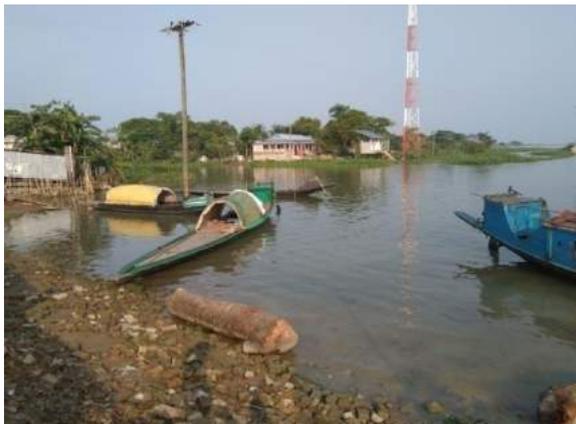
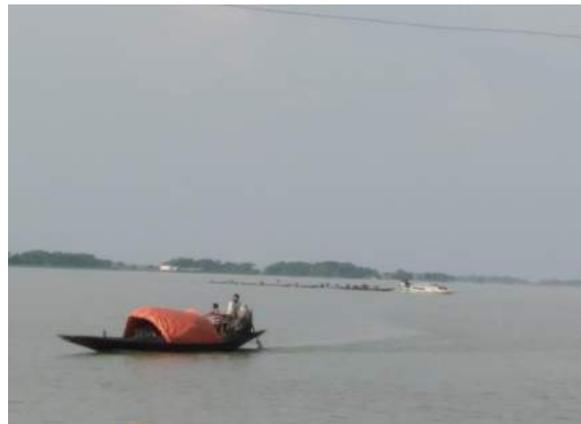
Figure 1.2: Different features of Chandra Sunarthal Haor System

Boat Ghat at Mahadipur

Partial View of Dharam Beel

Boat Ghat at Jyosree

Navigation in Chandra Sunarthal Haor

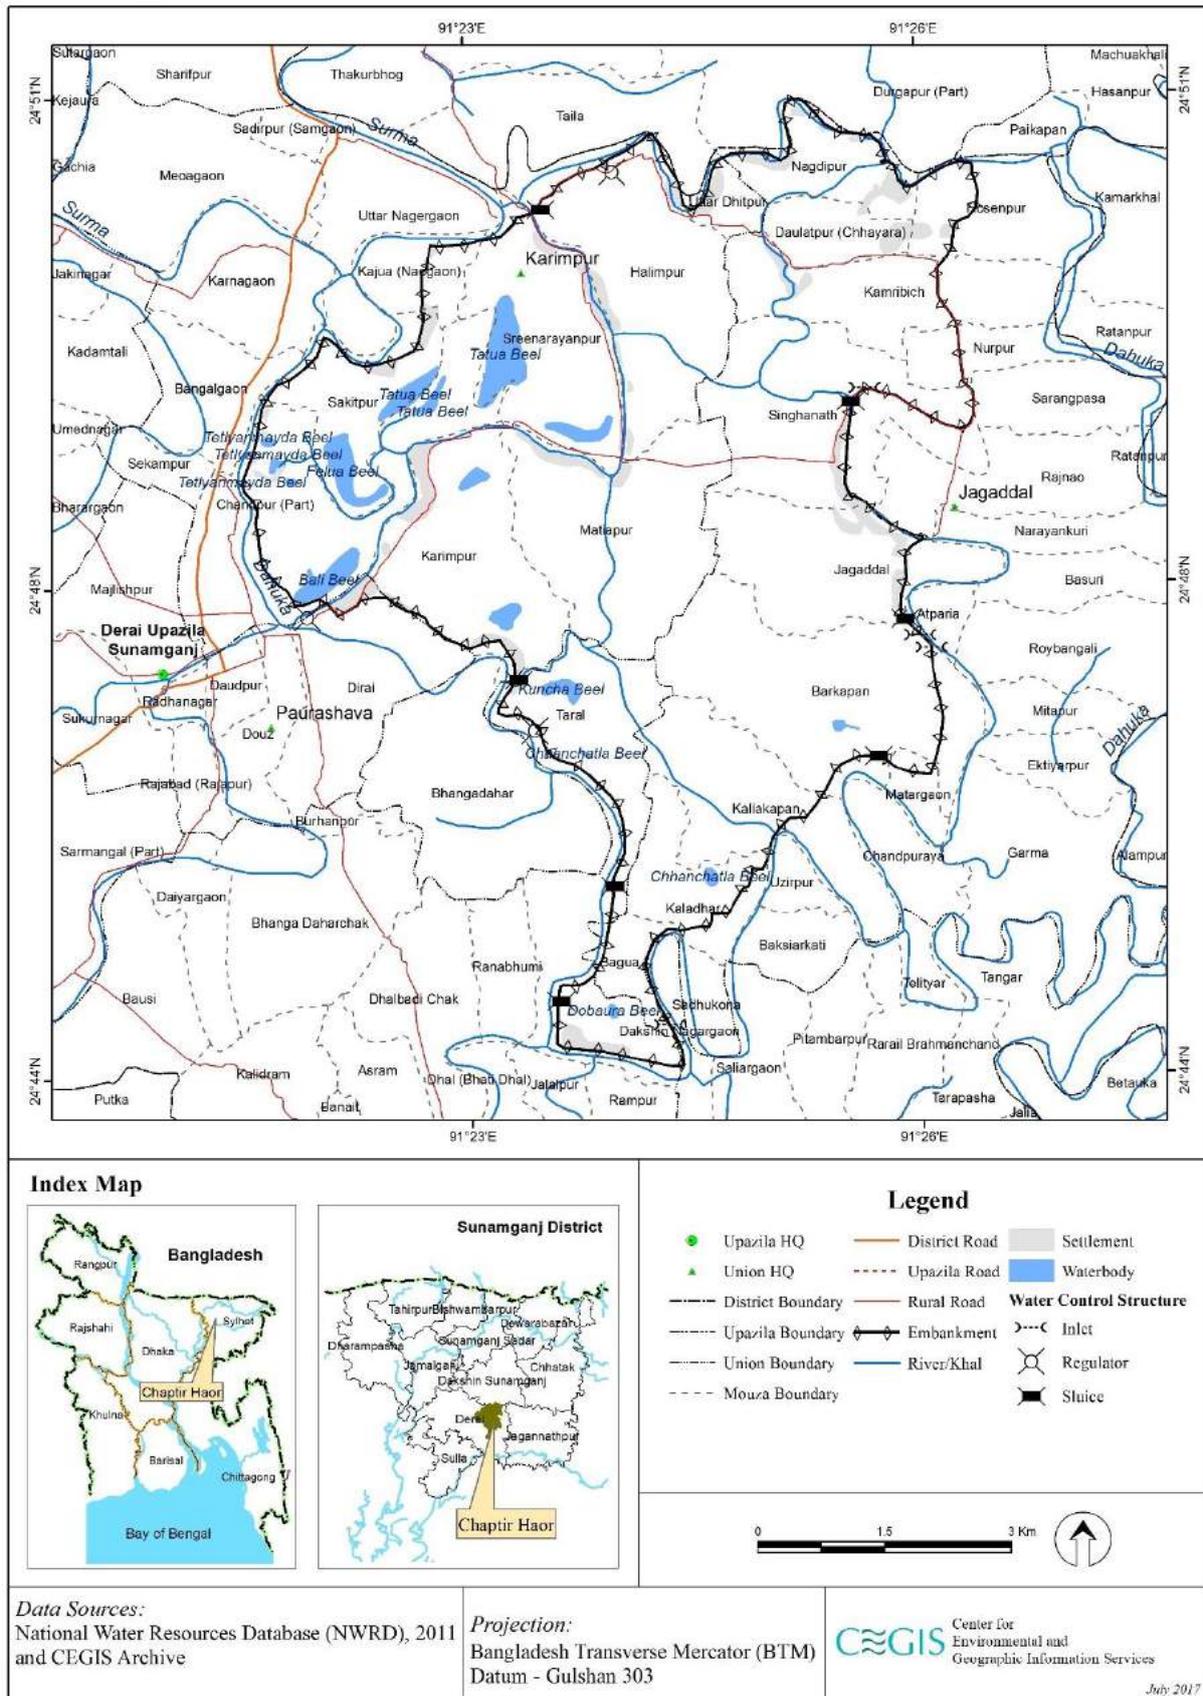
Figure 1.1: Hydrological Features of Chaptir Haor

Most of the interventions in the preoject area has become very old. Often they fail to operate properly. The embankment of the Chaptir Haor has deteorated in many plces. This causes untimely entry of flood water. The gates of most of the sluices are hard to drop and water becomes hard to control.

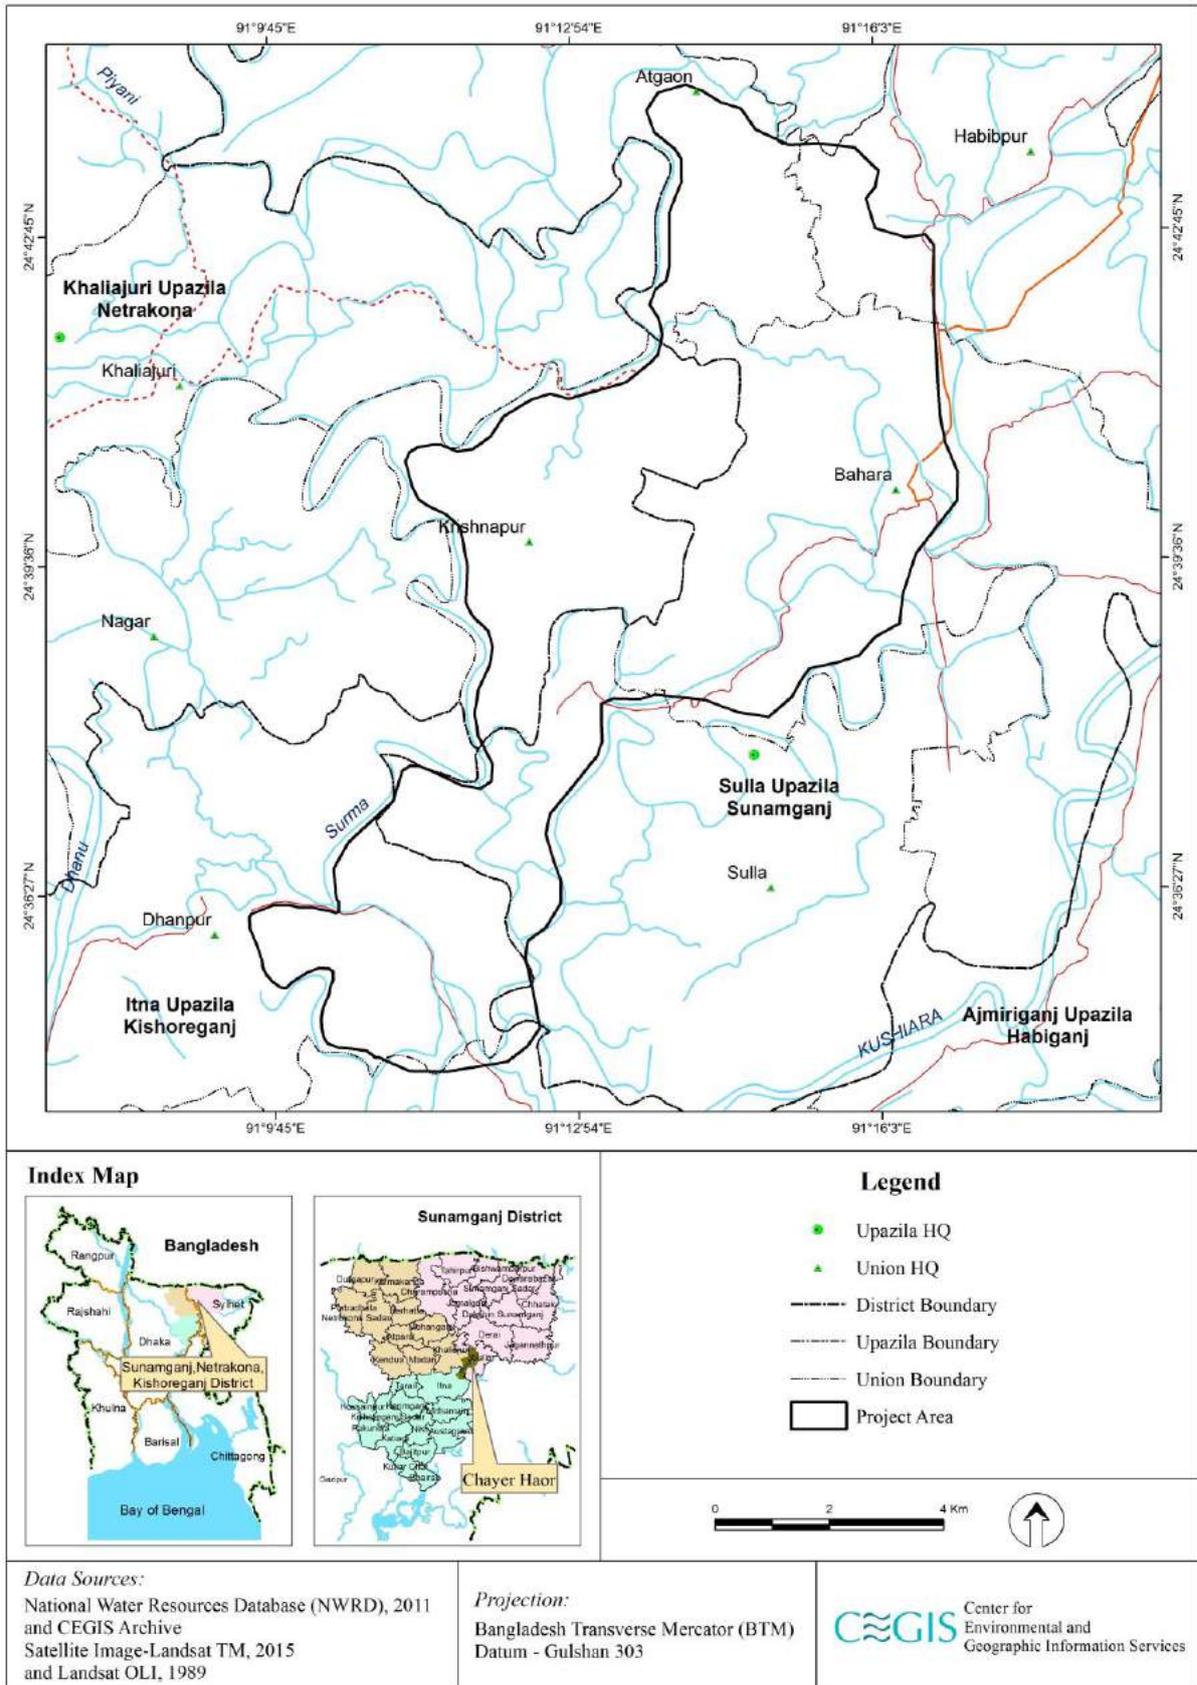
Figure 1.1: Hydrological Features of Chayer Haor System

Most of the interventions including the submergible embankment with regulators inside the project area are operational according to local people. The crest level of the embankment in Niamatpara, Anandapur and Durlavpur was seen to be below the design level and as a result, the water enters the earlier than it is supposed to be. The Sluice gate at Naziapur is 20 years old and sometimes it stars malfunctioning. Also, the regulators are not functioning

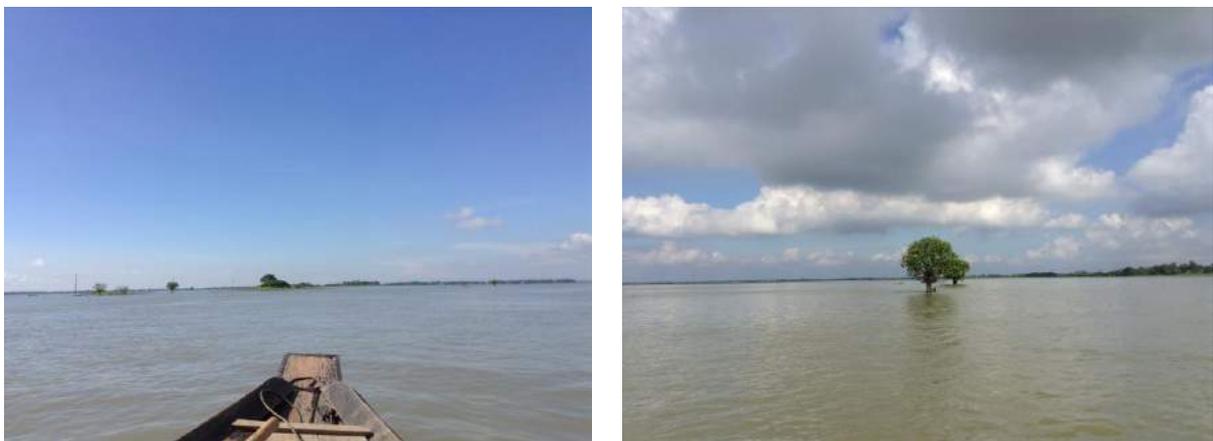
However, the flash flood sometimes comes early due to unprecedented rainfall in the upper catchment in Meghalaya which happened in March 2004 and 2017. The devastating flash flood inundated the entire haor area in the first week of March and damaged all the standing crops. It caused immense sufferings to the local populace. Some segments of the embankment were breached at that time. At present, the crest level of the embankment of Niamatpara, Anandapur and Durlavpur was found to be below the design level. As a result, flood water enters the haor through these areas within seven days which is supposed to enter after 10 to 12 days from its occurrences. As a result, flash flood causes crop damage and sufferings to the people every year.

Figure 2.1: Chayer Haor in the Monsoon Season

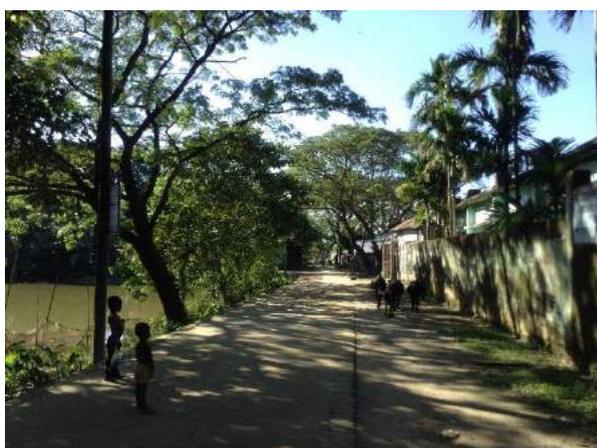
Figure 8.1: Embankment Road in the Study Area

After the period of project intervention, people started to use those submergible road or embankment as road to go to school, connecting roads, bazaar and health center etc. Though those embankments were not suitable for driving automobiles but people got opportunity to ply auto rickshaws and bike during the dry season. But in wet season, boat is the main sources of transport and communication in this region. But people have to wait for long time to travel to different places. They can hardly travel to the urban center twice or thrice a day. Due to the unavailability of the boats and trawlers, people with urgent health needs cannot come to the hospitals/ health complexes at the urban centers. These poor transport and communication problems many a people lose their lives in haor areas. Due to the lack of transportation, the incidence of death of children and pregnant women is higher and is quite unfortunate.

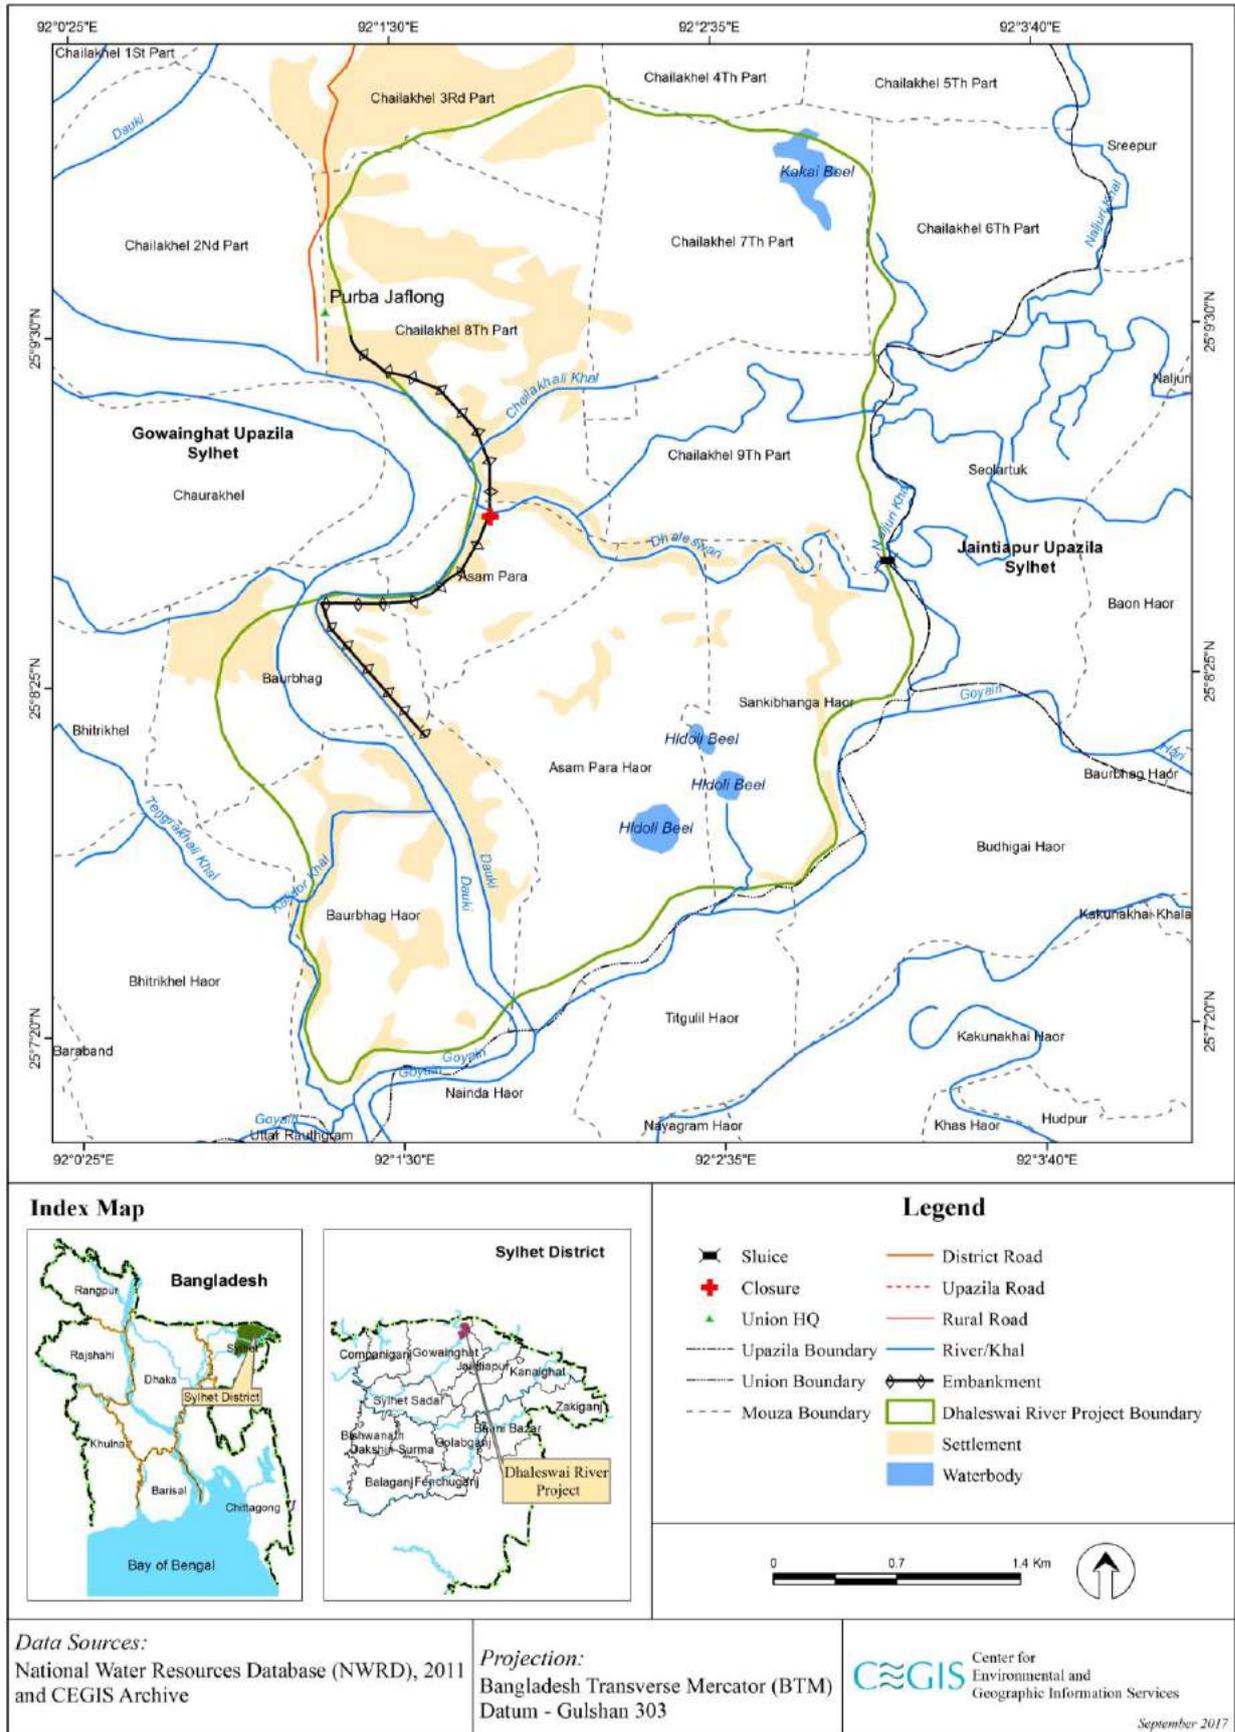
Figure 1.1: Hydrological Features of Dhaleswai River

The area normally suffers from flash flood in mid-April due to excessive rainfall in the Meghalaya. But, sometimes the flood occurs earlier like it happened in 2017 due to severe rainfall both in the upstream region and also inside the country. The farmers also cut the embankment to expedite the drainage after flood to start cultivation in dry areas. Moreover, the embankment also gets breached due to heavy onrush of flash flood. If the breached points or public cuts are not repaired in due time i.e. before onset of flash flood, flood water enters into the project through these weak points and damages crops.

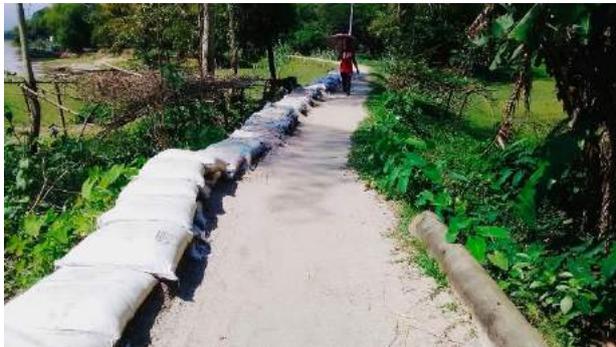
Figure 2.1: Dauki River Bank Protection

Interventions of the project have delayed the entrance of flash flood by 15-20 days. However, in recent years (2016 & 2017), flash flood entered into the project a bit early due to unprecedented rainfall in the upper catchment both in the upstream region and also inside the country. The farmers also cut the embankment to expedite the drainage after flood to start cultivation in dry areas. Moreover, the embankment also gets breached due to heavy onrush of flash flood. If the breached points or public cuts are not repaired in due time i.e. before onset of flash flood, flood water enters into the project through these weak points and damages crops.

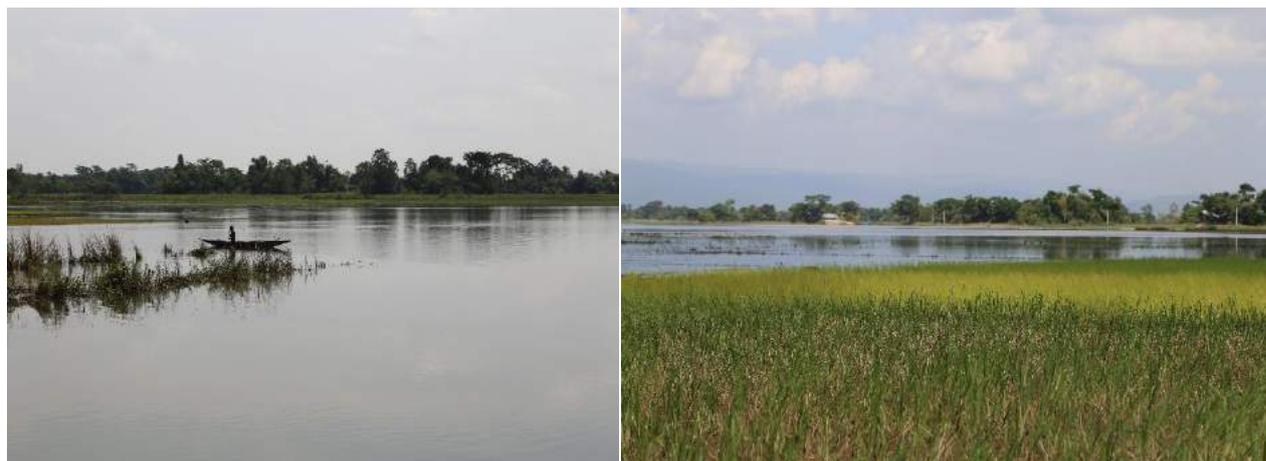
Figure 6.1: Fish Habitat of Dhaleswai Study Area

Post Intervention the total fish habitat is 1022 ha. Of which capture fish habitat 1012 and fish pond 10 ha. The perennial beel and floodplain are silted up partially due to flash flood. The connecting khals are silted up and loss the water holding capacity in dry season. Photo of fish habitat of the study area is given below **Figure 6.1**.

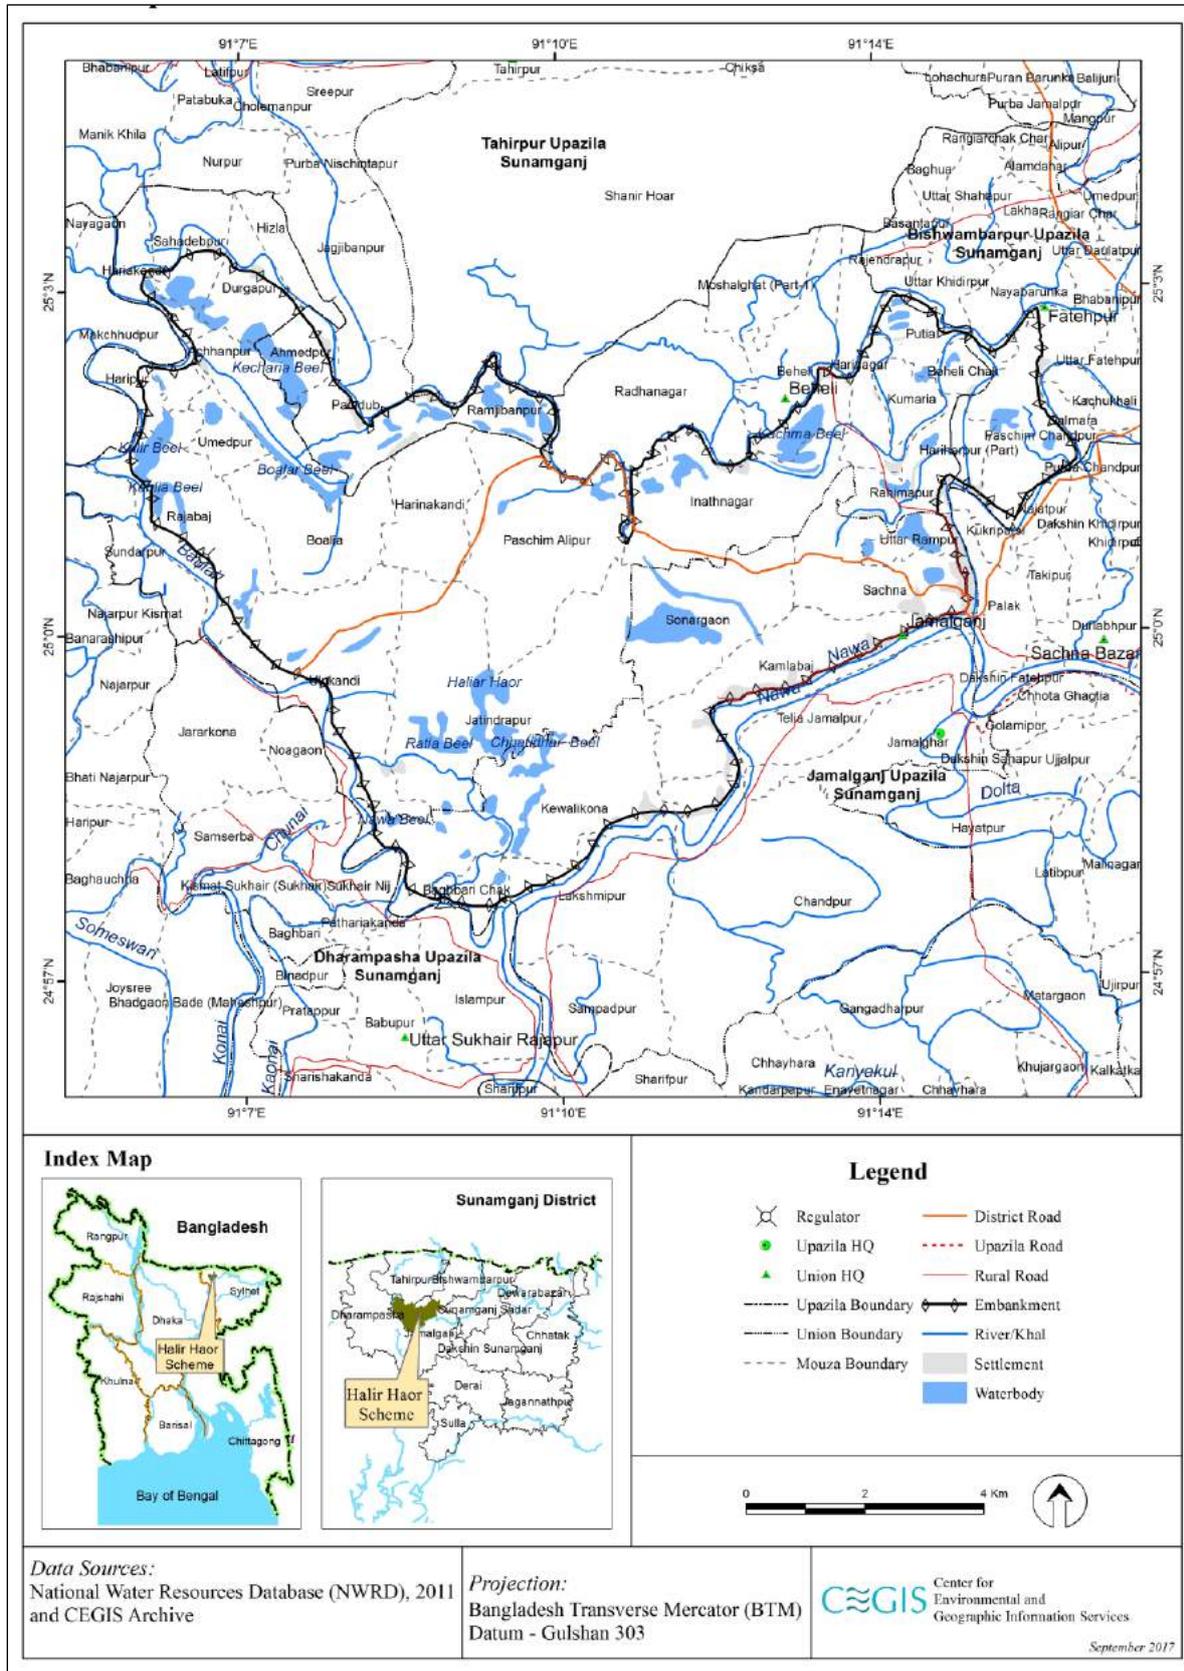
Figure 1.1: Hydrologic Features of Halir Haor system

crops. Moreover, Public cuts have been observed at different locations along the embankments due to lack of boat pass. Submersible embankment with Lowered crest level is incapable of serving its purpose. In this haor, two regulators have been observed. One of those are functioning well, however the other one is in non-functional state. Reasons behind low or non-functionality of hydraulic structures include: poorly fitted gates resulting to seepage flow, stresses relating to mechanical operation and missing of some valuable components of gates and hoist system, silted up linked canal creating drainage congestion etc.

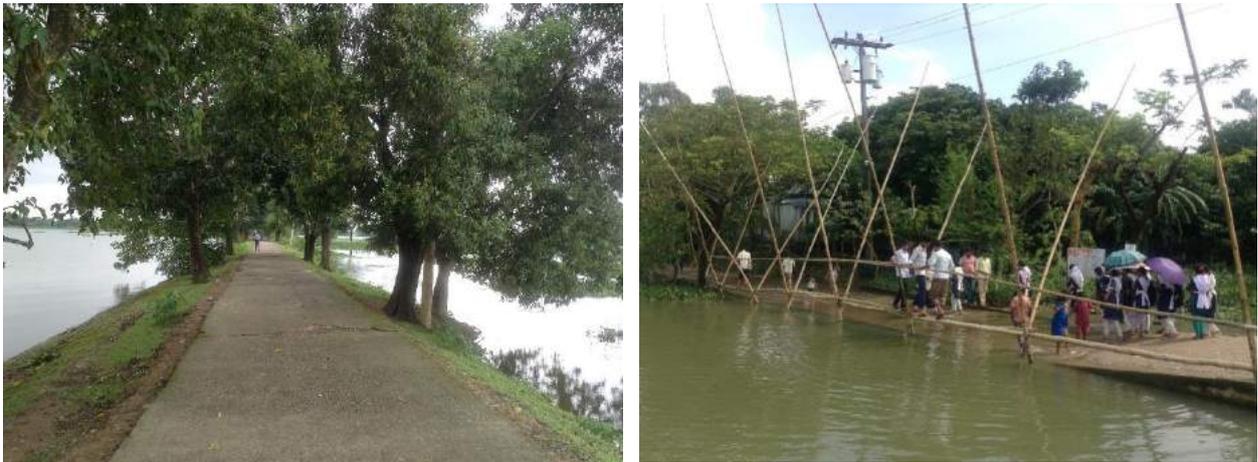
Figure 8.1: Submergible Road and an Embankment Road that Also Used as the Means of Communication

After the period of project intervention, people started to use those submergible embankment as road to go to school, highways, bazaar and health center etc. Though those embankments were not suitable for driving automobiles, people got opportunity to ply with auto rickshaws and bikes during the dry season. But in wet season, boat is the main sources of transport and communication in this region.

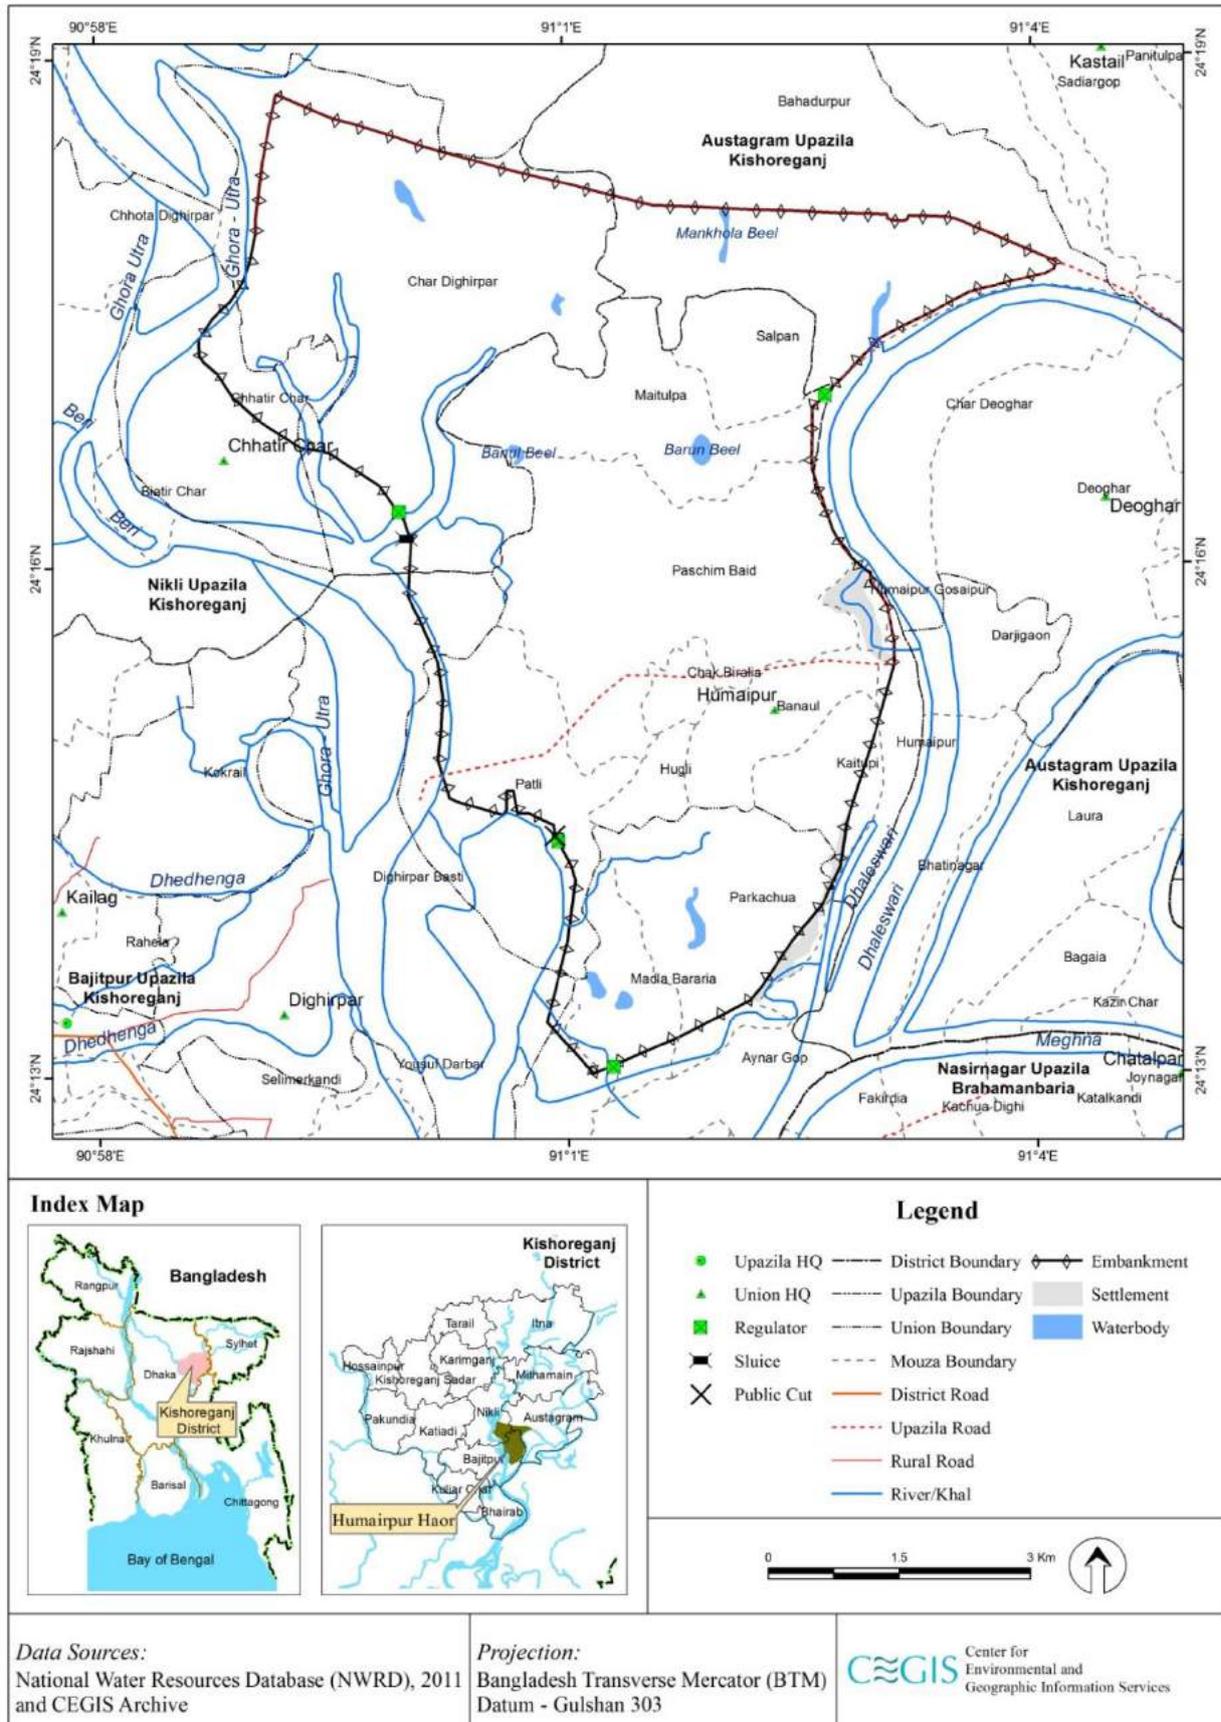
Figure 1.1: Hydrological Features of Humairpur Haor System

The Humaipur Haor Project was initiated in the 50s decade of the last century. After that no major repair work was done to the embankment of this project. As a result, the embankment has eroded a lot throughout the project area. This decayed embankment cannot withstand the pressure of the water and is getting damaged more every year.

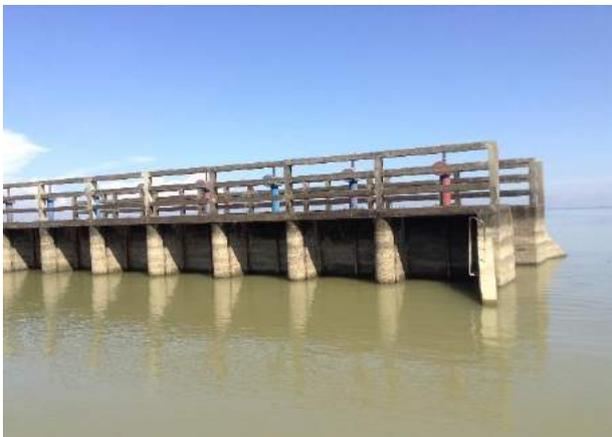
Figure 1.1: Regulator at Balanpur

Bangladesh Water Development Board (BWDB) implemented the Kalikota Haor Project during 1978-1993 with GOB fund. The main objective of the project was to protect Boro crops from early flash flood as well as to protect life and properties from flooding. The water management infrastructures of the Kalikota Haor Project include the following:

- Embankment: 77 km including compartmental embankment;
- Regulator: 2 Nos.;
- Pipe sluice: 3 Nos;
- Culvert: 6 Nos. in compartmental embankment.

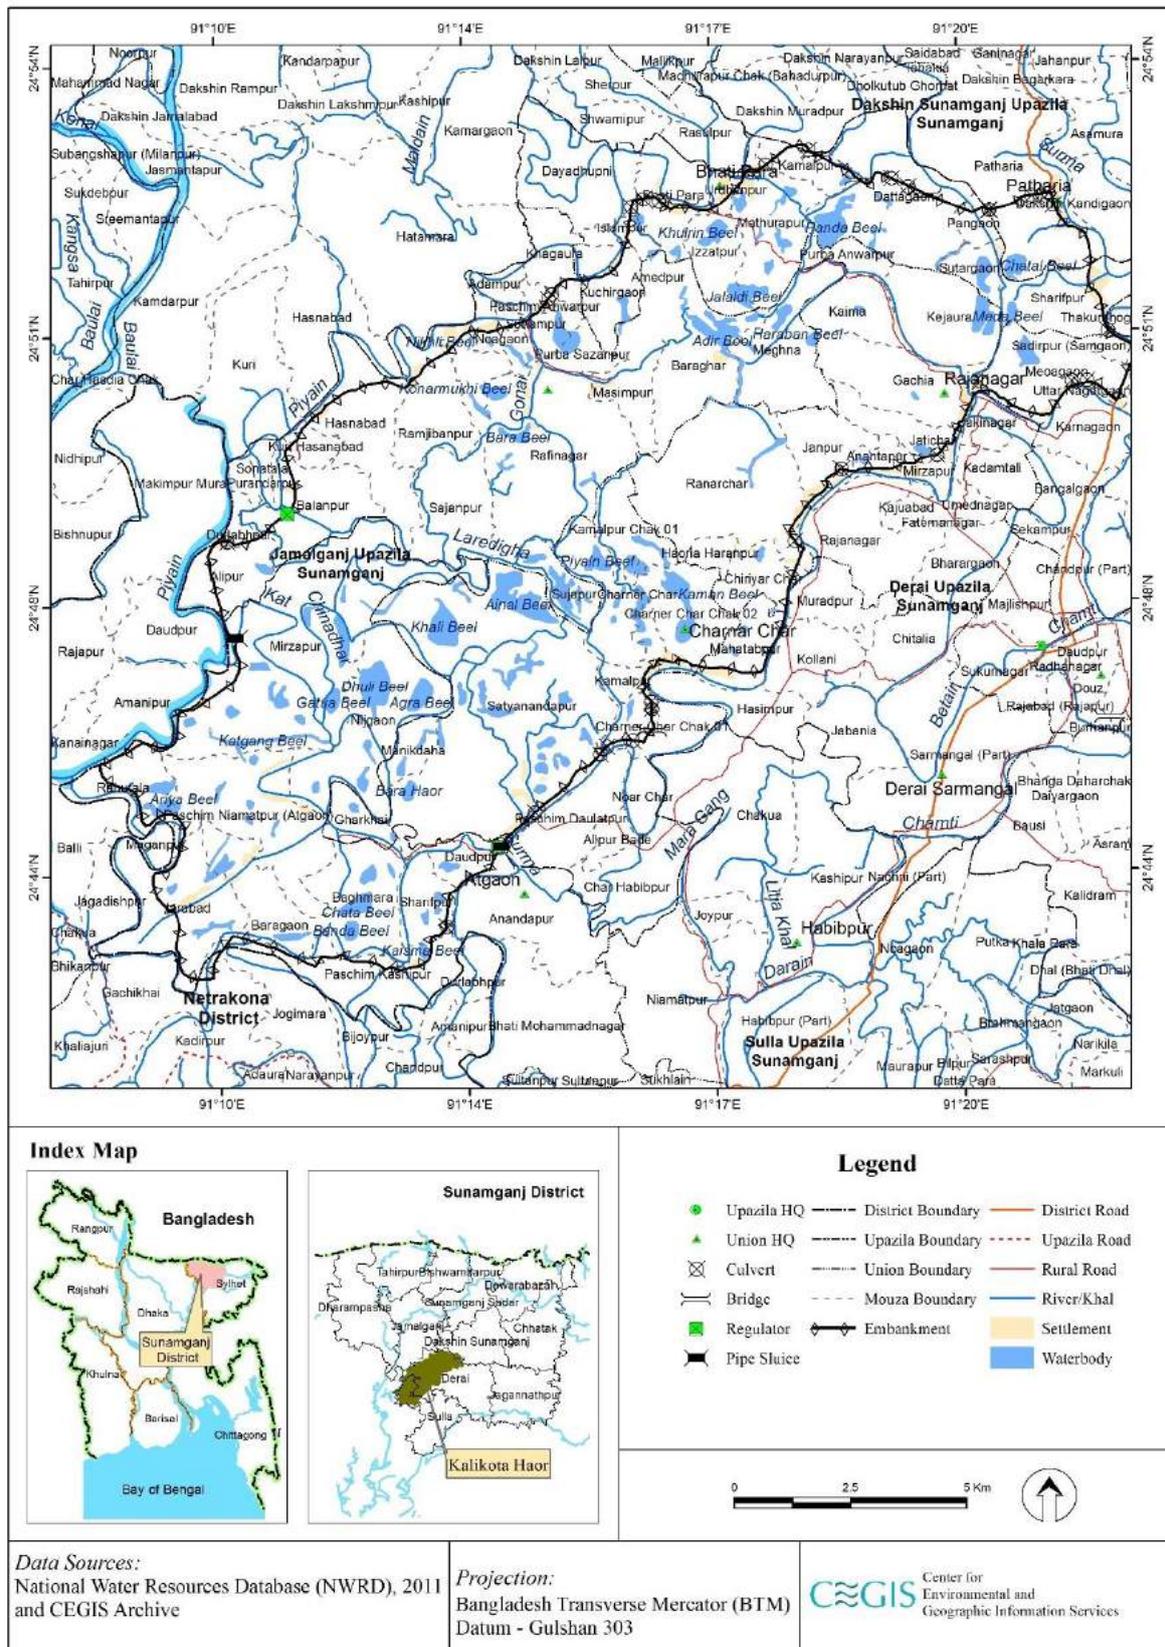
Figure 1.2: Hydrologic features of Kalikota Haor

Major interventions include submergible embankment and some different types of appurtenant hydraulic structures like regulator, culvert, bridge and pipe sluice. Submersible Embankments are the most common structural interventions in this region. It is observed that along majority part of the embankments, the crest level recedes from the design crest level, existing cross-sections receive damage compared to design cross-section and breaches of embankments are found at numerous locations Breaches allow water entrance into the haor areas before harvesting of boro crops is done leading to severe damage to the crops. Moreover, Public cuts have been observed at different locations along the embankments due to water drainage. Submersible embankment with Lowered crest level is incapable of serving its purpose. In this haor, considerable numbers of culverts and two regulators have been observed. The regulator at Balanpur is functioning well, however the other regulator at Daudpur is in non-functional state. Reasons behind low or non-functionality of hydraulic structures include: poorly fitted gates resulting to seepage flow, stresses relating to mechanical operation and missing of some valuable components of gates and hoist system, silted up linked canal creating drainage congestion etc.

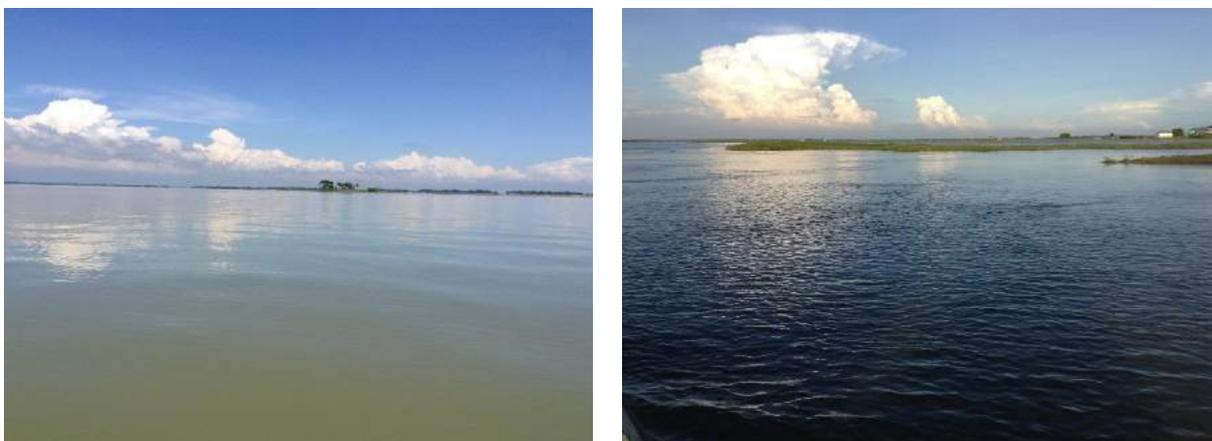
Figure 2.1: Kalikota Haor in Wet season

After implementation of submersible embankment in Kalikota Haor, entrance of flood into haor got delayed by 9-10 days. The flash flood enters through khals as well as by overtopping the submersible embankment in last week of April and inundates the entire project area within a week. The local people informed that after implementation of the embankment, they could harvest their crops and safeguard the livelihood due to delayed inundation by the flash flood.

However, the flash flood sometimes comes early due to unprecedented rainfall in the upper catchment in Meghalaya which happened in 2004 and 2017 in March. The devastating flash floods inundated the entire haor area in the first week of March and damaged all the standing crops. It caused immense sufferings to the local populace. Some segments of the embankment were breached at that time. At present, the crest level of the embankment of Islampur, Pangaon and Kamalpur was found to be below the design level. As a result, flood water enters the haor through these areas within 6 to 7 days which is supposed to enter after 9 to 10 days from its occurrences. As a result, flash flood causes crop damage and sufferings to the people every year.

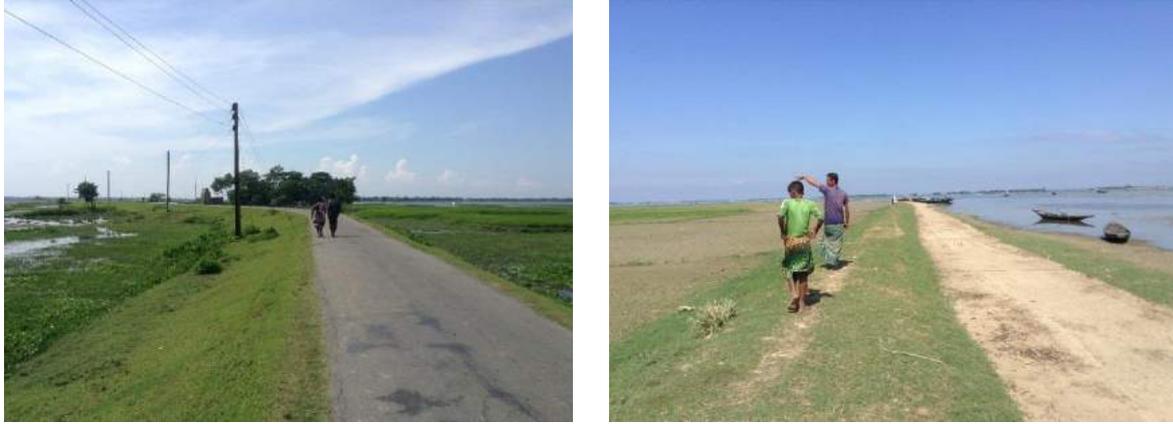
Figure 8.1: A submergible road and an embankment road that also used as the means of communication in Kalikota Haor, Sunamganj

After the period of project intervention, people started to use those submergible embankment as road to go to school, highways, bazaar and health centre etc. Though those embankments were not suitable for driving automobiles, people got opportunity to ply with auto rickshaws and bikes during the dry season. But in wet season, boat is the main sources of transport and communication in this region.

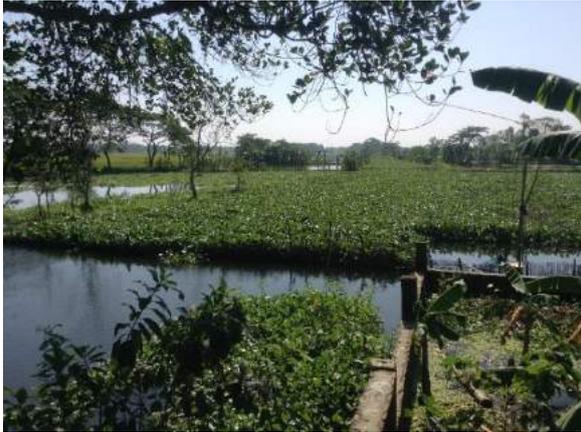
Figure 2.1: Fish Cultivation with Wooden Fencing in the middle of the River

The re-excavation of the Singua River and Khals in 1979 smoothened the drainage of water. This continued for 20-25 years. However, the drainage is being impeded for the last 10-12 years. Moreover, it was found during the field visit that the farmers are taking possession of the river by filling it up leading narrowing the river. Construction of a bridge near the connection point of Ramerpuri beel and Singua River has narrowed the river also. Due to accumulation of siltation, the gates of sluice gate in Bahadia cannot operate timely which hampers the drainage facility of the river. As a result, the downstream area in Mulladi and Angiadi is suffering from water logging even in the dry season. It was also observed that the people living

near the river area, has blocked the drainage path with wooden fence and earthen dam to cultivate fish hindering the natural drainage of the water.

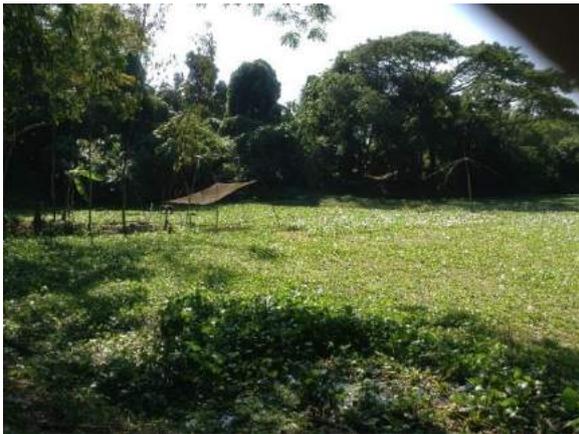
Figure 2.3: Water Hyacinth

The scenario of navigation has not changed too much even after re-excavation of river and khals. In recent time, cockles are used to carry Jack-Fruits in the monsoon to the nearest markets from different villages. Excessive water hyacinth, settlements in the middle of the river, fish culturing with ring fence etc. are obstructing the plying of boats through the river.

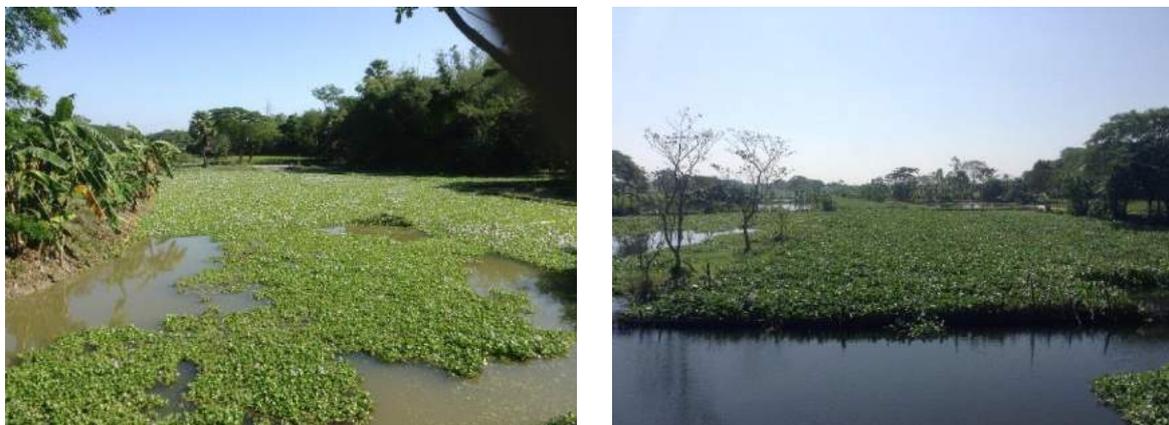
Figure 5.1: Fish habitat of Singua River

In post Intervention period the total fish habitat is 1877 ha. Of which 1827 ha capture fish habitat and 50 ha culture fish habitat. The water area increase due to siltation in the mouth of river. The connecting khals are silted up and loss the water holding capacity especially in dry season. In some area the land owners are converting the floodplain to culture fish habitat. And culture habitat is increasing day by day especially in Banagram, Noapara, Nadna village area. Huge water hyacinth present that disturb the fish movement. Photos of fish habitat of Singua River area are given below in Figure 5.1.
