Department of Bangladesh Haor and Wetlands Development
Ministry of Water Resources

Impact Assessment of Structural Interventions in Haor Ecosystem and Innovations for Solution

Field Report of BWDB Schemes

Volume III

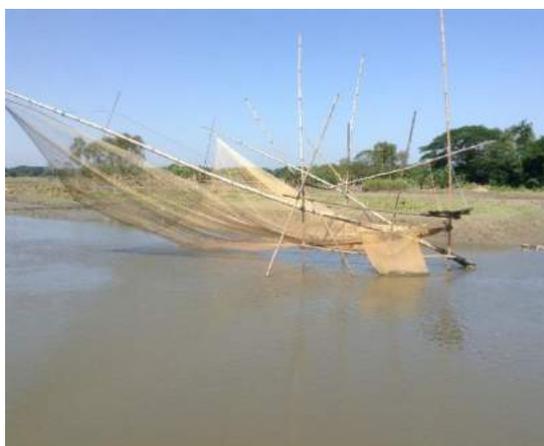
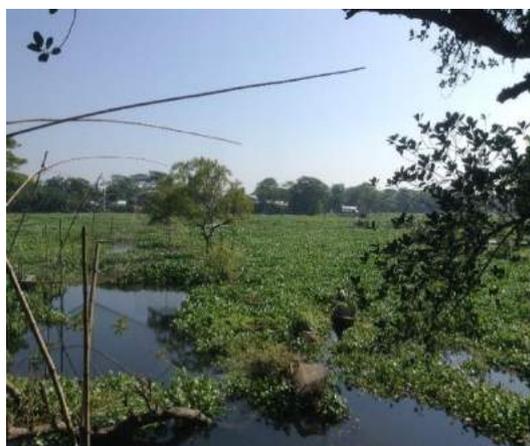
Figure: 5.3 Types of fishing gears of Singua River

At present the fishers are using the gear which was almost used earlier. At present some new nets and traps like moshari jal (small mesh size net below 0.1 cm) that are using to catch the fish which are damaging the fish fry as well as habitat quality. *Kironmala* (one kind of trap made by plastic sheet and use fish feed inside the trap to catch fish) are using to catch gura icha. No lease system present.

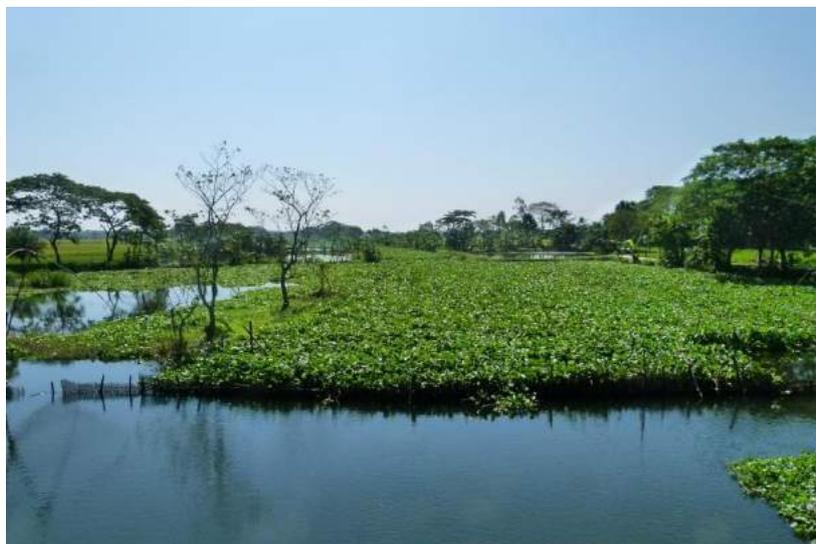
A. Singua River filled with water hyacinth at Molladi Village

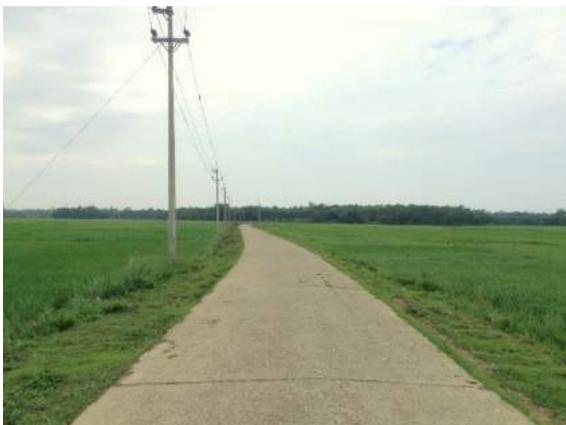
Figure 8.1: Submergible roads in the Surma haor system area

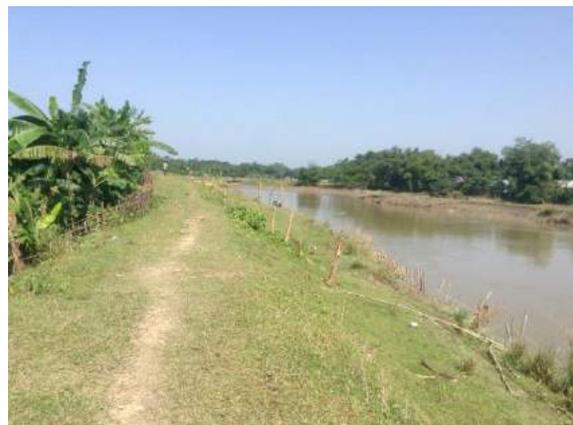
Figure 8.2: River bank embankment in the Surma haor system

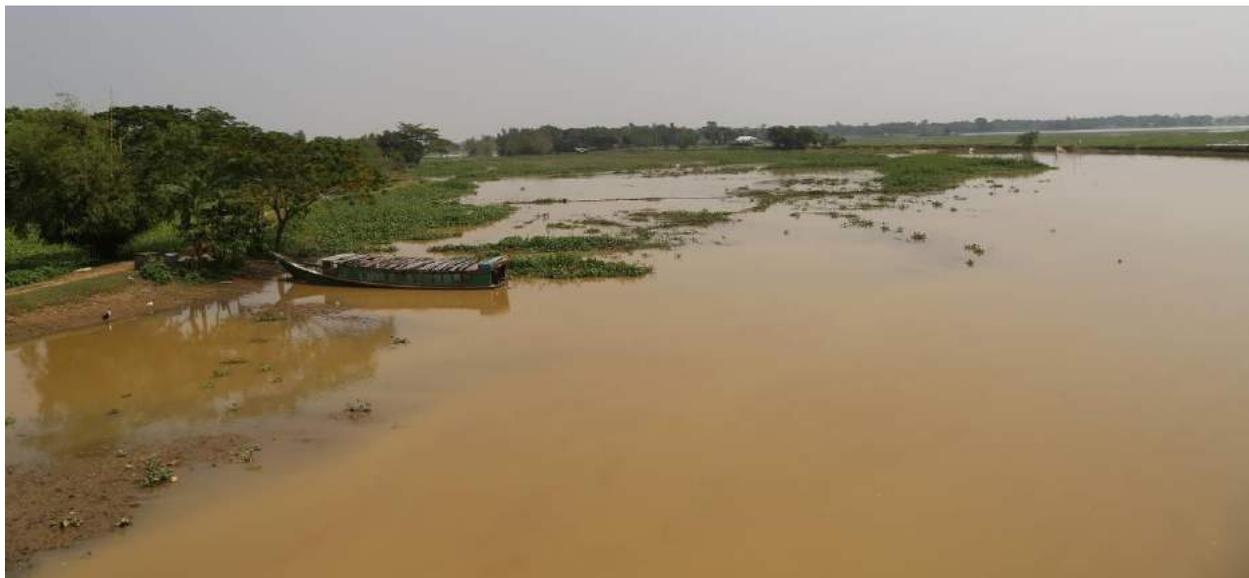
Siltation of waterbodies inside this haor has disfavor the luxurious succession of water lily. However, this situation is common at the peripheral area of Updakhali and Gumai River. Except the mentioned area, this free floating plant is quite common all the areas. Overfishing activities caused drastic depletion of Makhna (*Euryale ferox*) and Singara (*Trapa bispinosa*) populations. Although the abundance of the amphibian plant have increased (mentioned earlier) but the diversity and occurrences of free floating plants (i.e. Water Hyacinth, *Pistia* and *Azolla*) have changed and their occurrences are limited within untouched stagnant ditches and homestead ponds.

(Picture taken October 2017, from Ambari Bazar of Pogla UP)

Figure 7.2: Silt water of Gumai River disfavor succession of most aquatic flora at surrounding areas

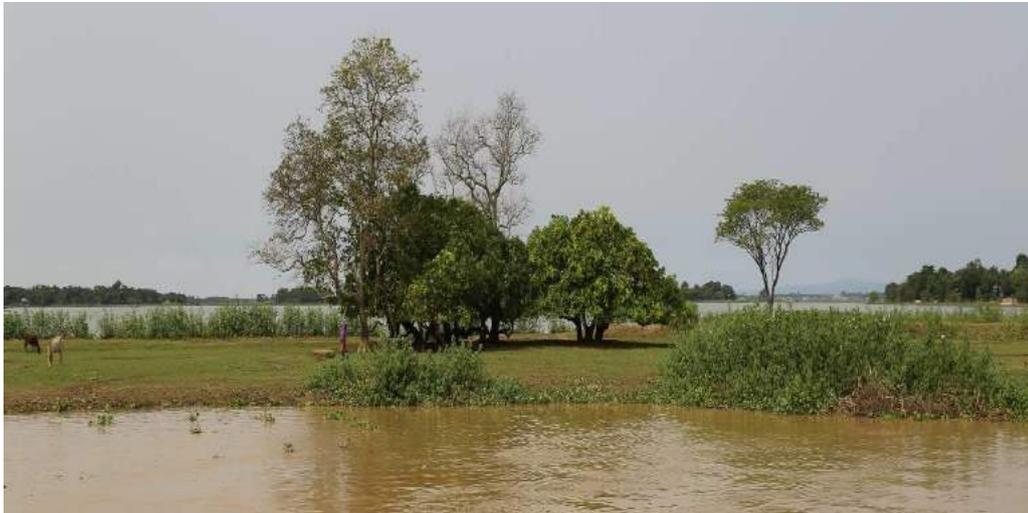
Swamp forests of this haor have been destroyed due to extension of agricultural practice for more crop production. Cattle grazing is another main cause for the destruction of swamp forest. Yet, there is still some tresses of swamp forest at the peripheral 'kandas' along the Updakhali River.

(Picture taken October 2017)

Figure 7.3: A Part of Remaining Swamp Forest at the Bank of Updakhali River near Keshobpur Village
